## **Soil Stabilisation for Reduced Cost Slurry Storage**

**Final Report for BPEX Ltd, EBLEX Ltd and DairyCo Ltd**

**October 2009**

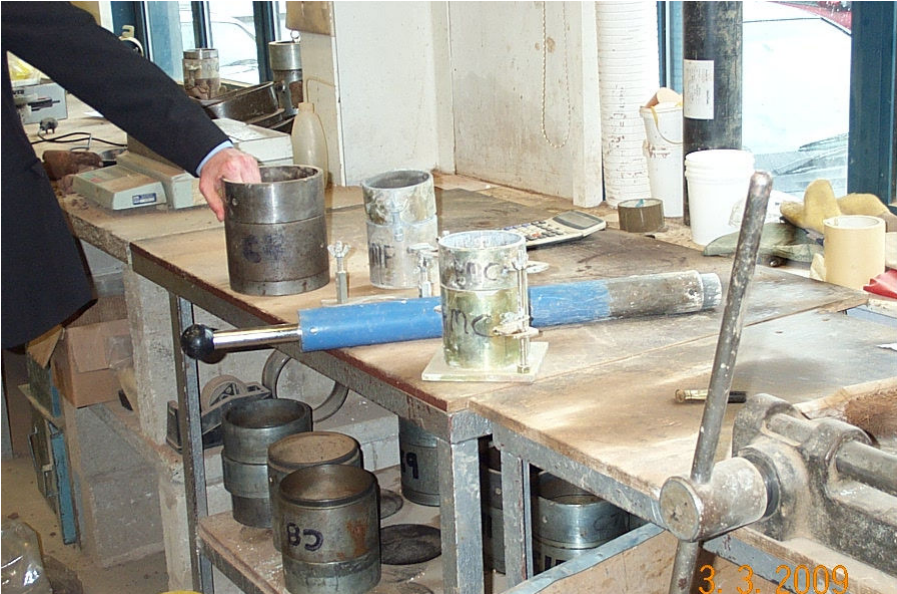
Figure 2. Sub-soil sample moulds and compacting instrument – GeoTest laboratory

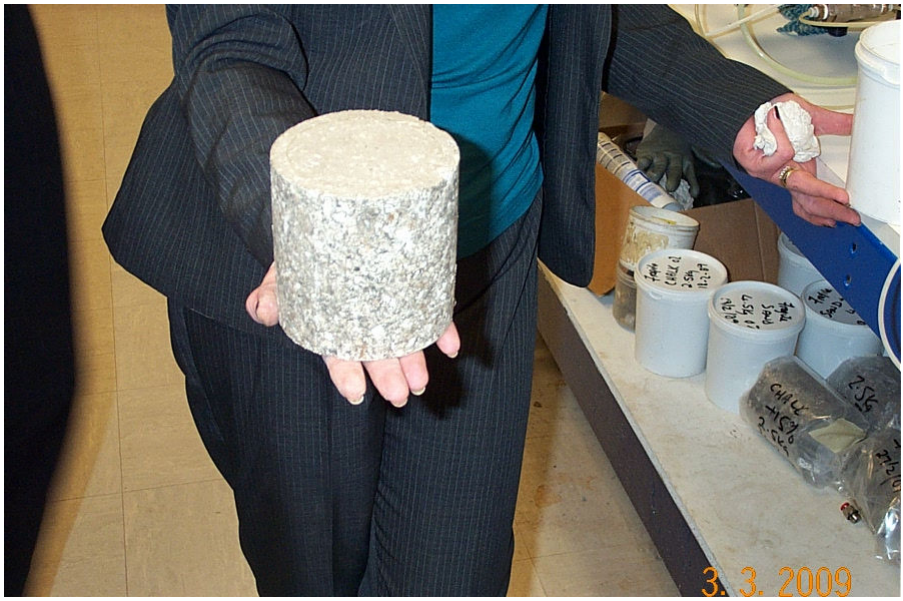
Figure 3. Compacted chalky sub-soil sample with cement inclusion

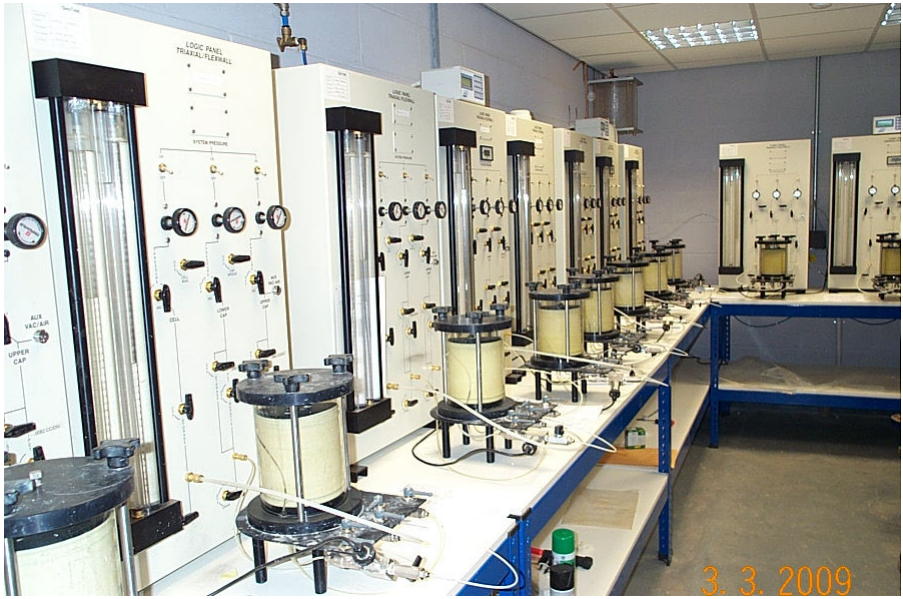
Figure 4. Sub-soil samples - Permeability testing at GeoTest laboratory

Prepared specimens were stored for approximately 23 days before commencement of testing with the aim of the permeation phase of the test taking place when specimens were 28 days old. Triaxial Permeability tests in accordance with BS 1377:1990 Soils for civil engineering projects, Part 6, method 6 were carried out using an effective pressure of 50kPa, a hydraulic gradient of 20 and downwards flow through the specimen. The permeability of each specimen was determined when flow volumes from upper and lower inlets were linear and parallel.

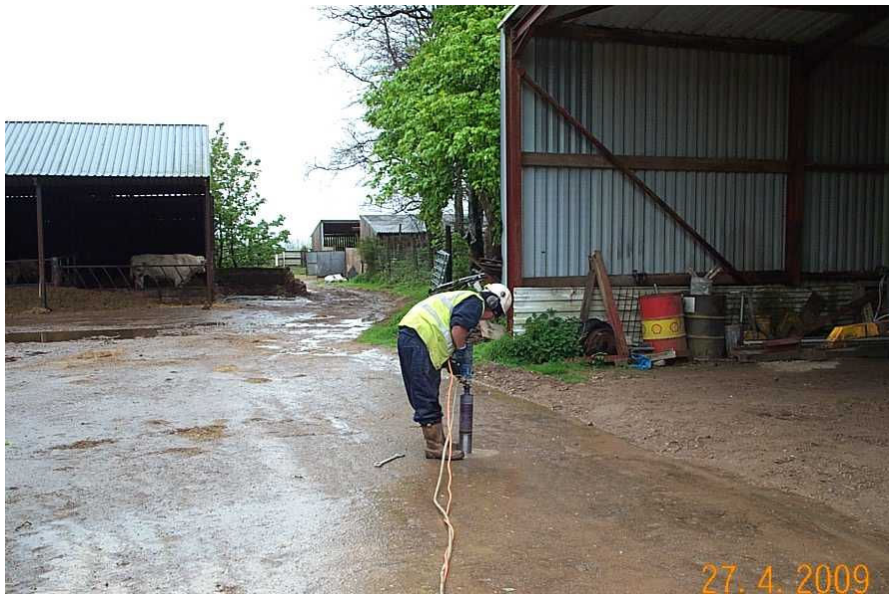
Figure 5. Coring at Warren Farm yard area

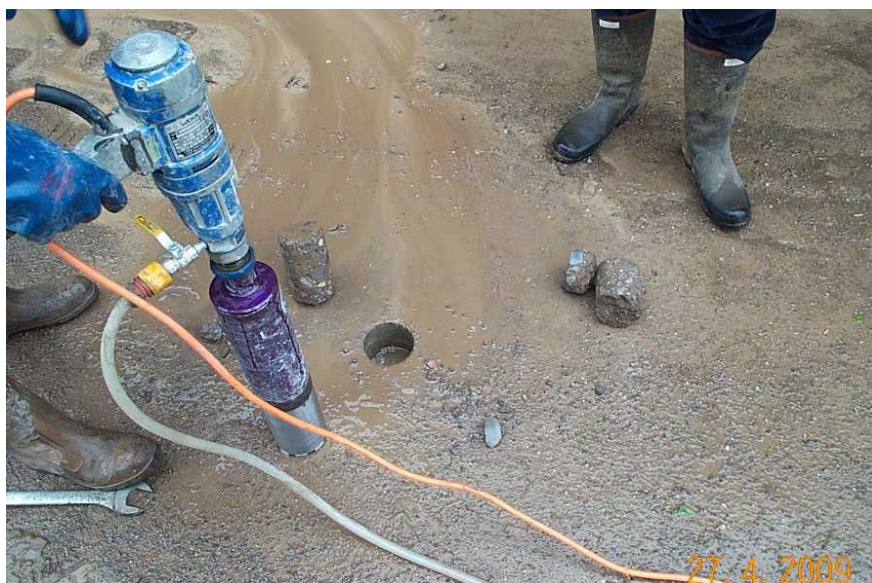
Figure 6. Coring equipment showing core removed

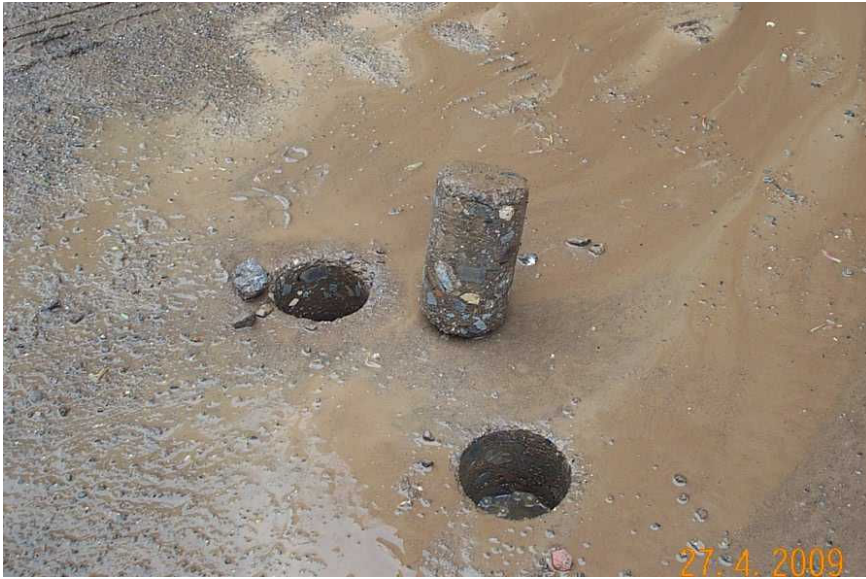
Figure 7. Core of stabilised soil material

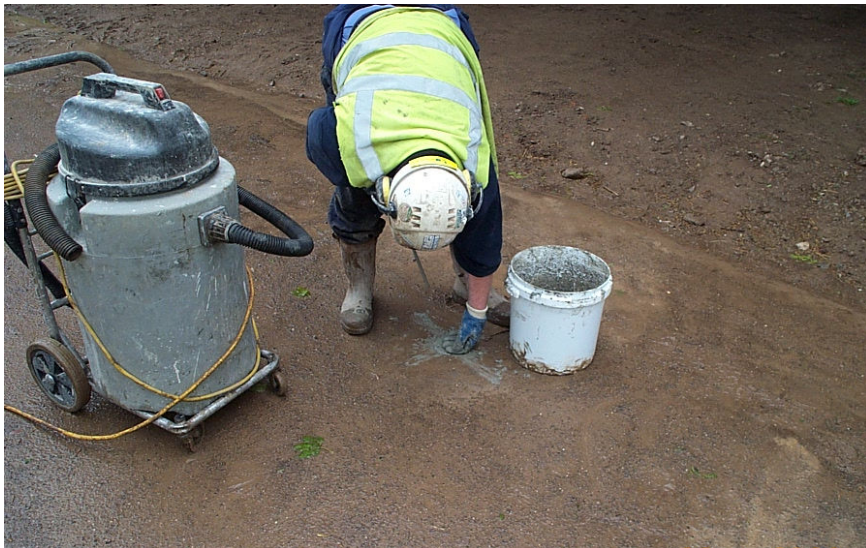
Figure 8. Vacuum used to clean out core holes prior to reinstating with concrete mix

All the cored holes were reinstated on completion with concrete.

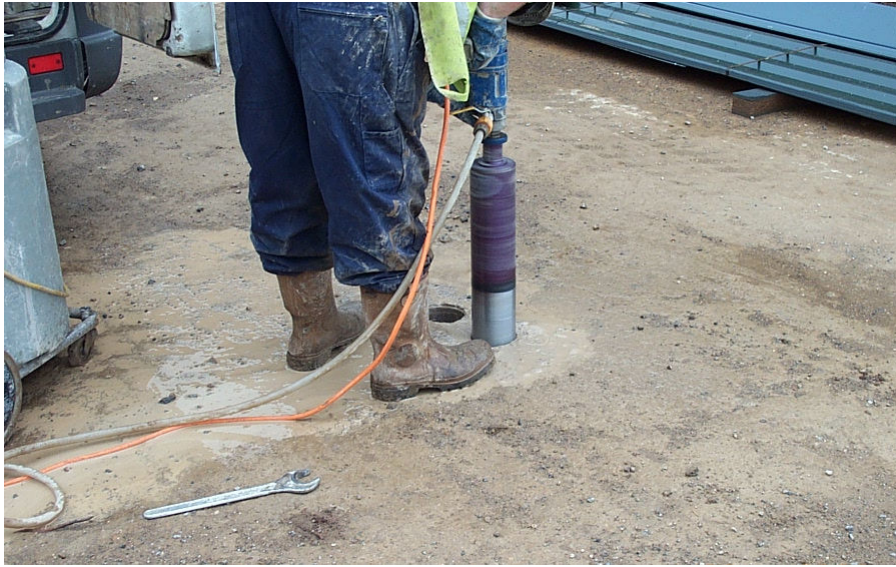
Figure 9. Cores taken from an area of yard containing a higher percentage of aggregate – Warren Farm

For comparative purposes, a core was taken in a nearby yard area where less aggregate was used in the stabilisation process. This core disintegrated on extraction. Two further cores were also taken in another stabilised yard area where more aggregate was used in the process. These cores were found to be more solid.

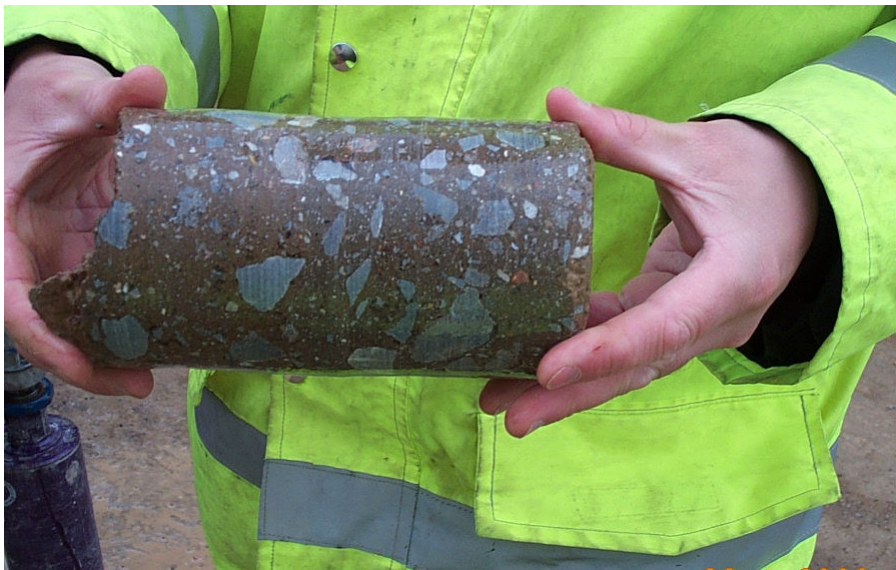
Figure 10. Example of core containing a higher percentage of aggregate

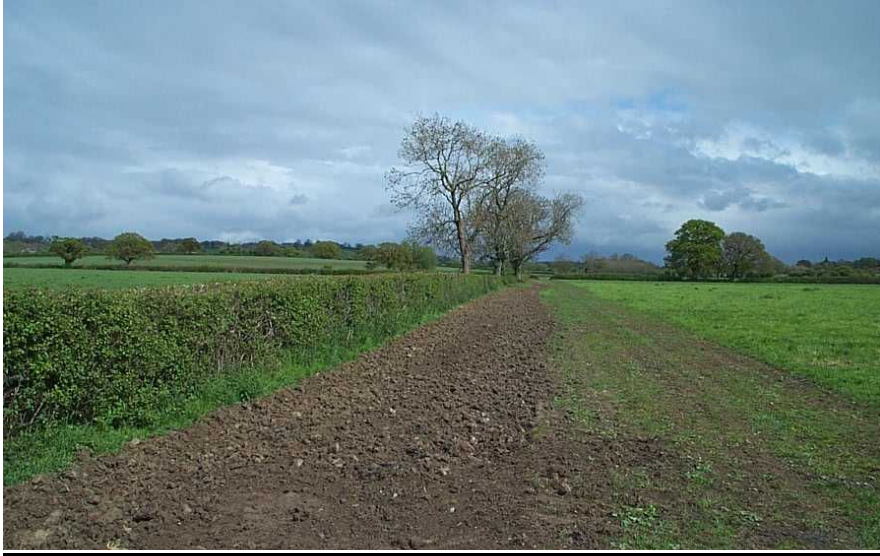
Figure 11. Bridge Farm - view along stabilised cow track before coring

The Kingshay cow track appeared to be rather, a stabilized layer of soil, than a consolidated/compacted layer (Figures 11-14), so the high permeability recorded with those cores was not unexpected (Table 3). However, cores taken from the Goldings yard, Warren Farm (Figures 5 – 10), also gave disappointing results from the permeability tests. In this case, the soil-cement-aggregate mix (Figure 10) would have been laid according to best operating procedures and would have included the wet mix approach, which might be expected to give best results.

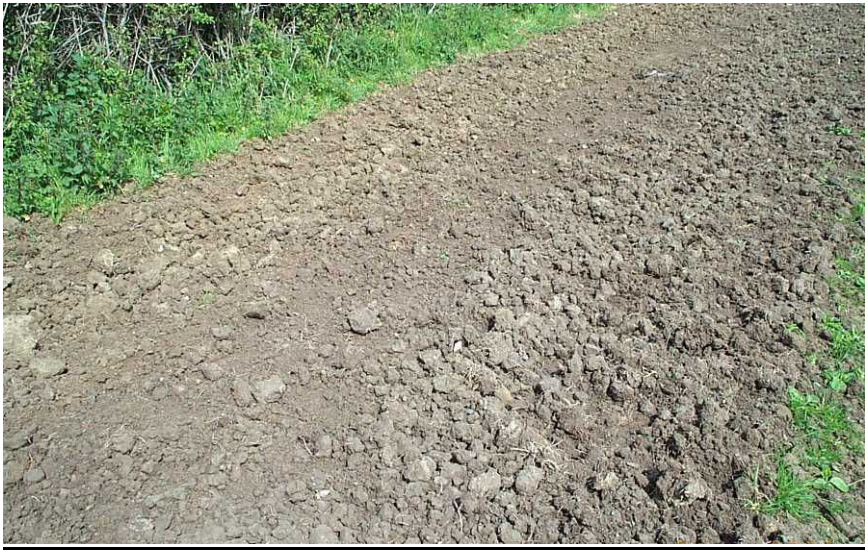
Figure 12. Close-up of surface of stabilised cow track

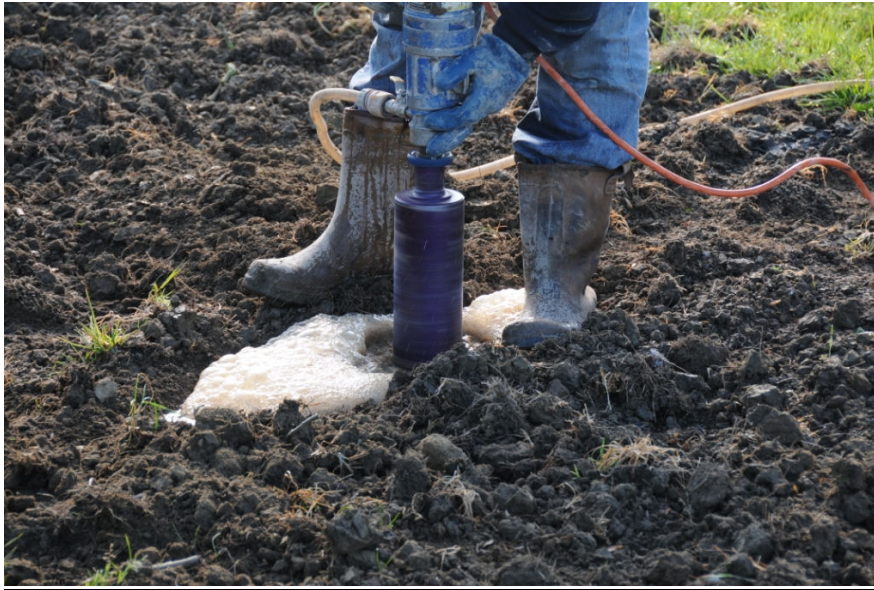
Figure 13. Bridge Farm - coring the cow track

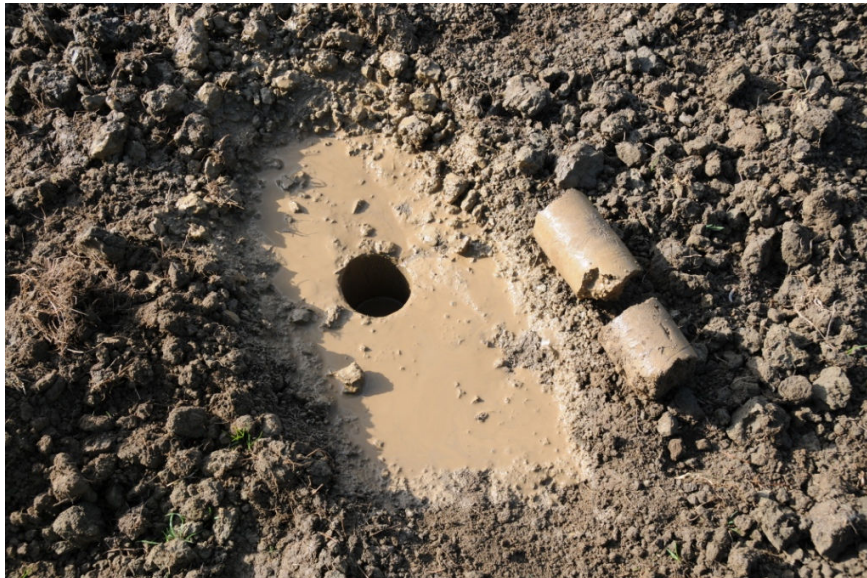
Figure 14. Bridge Farm - after core removed

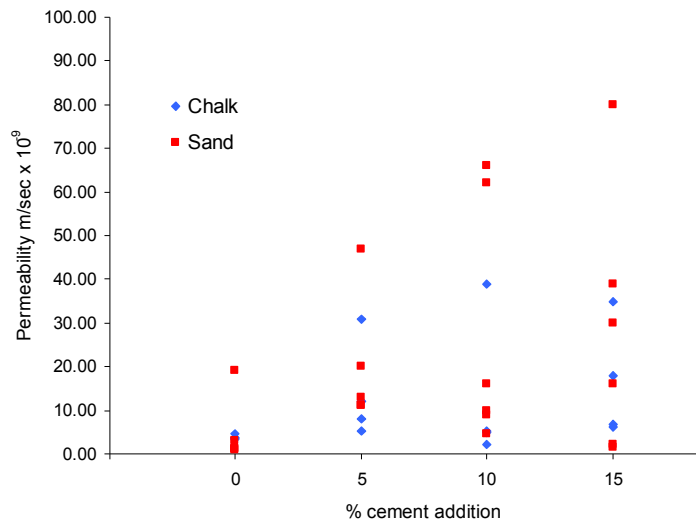
Figure 15. Soil permeability test results and rate of cement addition

A summary of the key results from the soil mix permeability tests, including also the latter, wet mix tests, is presented in Table 2. Full details of the wet mix test results are presented in Appendix 3. Overall, permeability test results were disappointing, with only four sample mixes (out of a total of 38 mixes) attaining near to, or below, the minimum standard required ( $<1 \times 10^{-9}$  m/second) for suitability for use in lagoon construction (Anon, 1991). These four sample mixes (highlighted in blue text) were all of the sandy soil, but only one of these included any cement addition (15% cement, light compaction). Neither did there appear to be any systematic difference between the results obtained for the sandy and chalk soil types. Moreover, with the results for the two soils plotted according to rate of cement addition (Figure 15), there appeared to be no discernible benefit of cement addition to resulting permeability; rather the contrary, with cement addition to the soil mix tending to increase the permeability of the final mix.

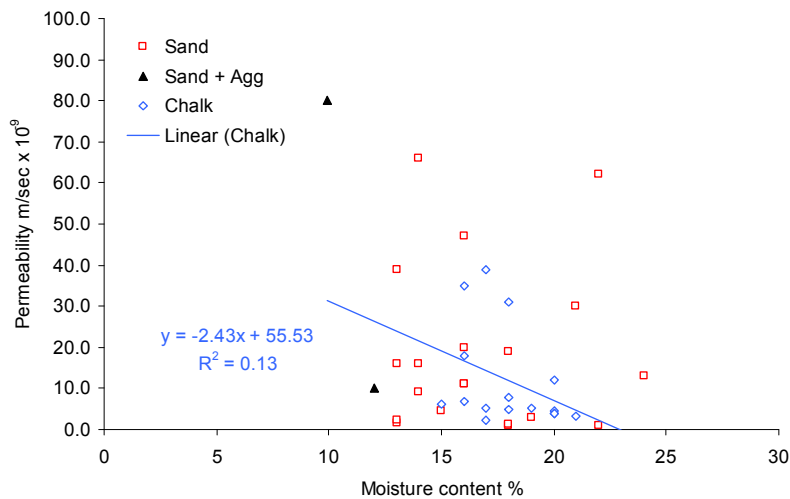
Figure 16. Soil permeability test results and initial moisture content of mix.

Moisture content of the mix might be anticipated to impact on the compactability and, hence, the permeability of the mix; however, there appeared to be only a very weak relationship, or general trend towards reducing permeability (see Figure 16) and that only for the chalk soil.
