## **Soil Stabilisation for Reduced Cost Slurry Storage**

**Final Report for BPEX Ltd, EBLEX Ltd and DairyCo Ltd**

**October 2009**

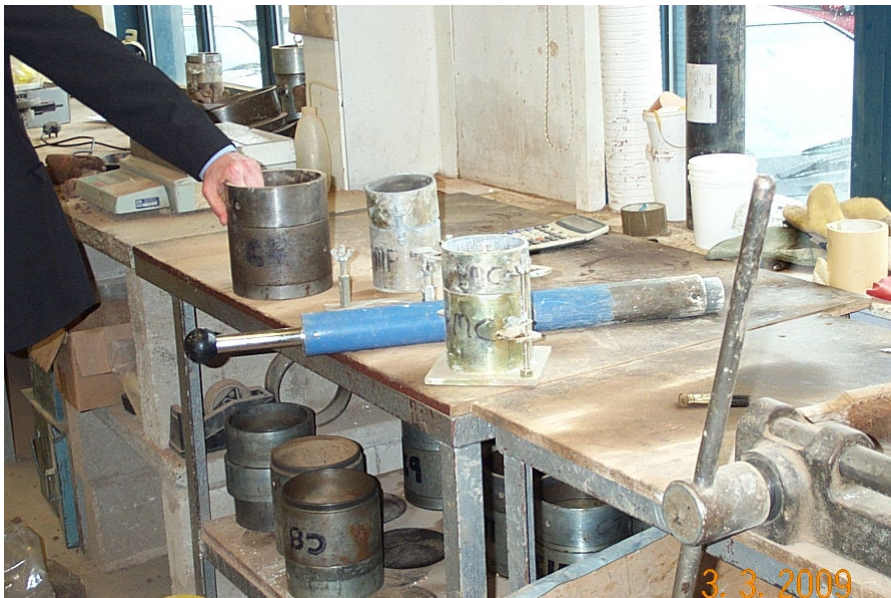
Figure 2. Sub-soil sample moulds and compacting instrument – GeoTest laboratory

A test portion of material of suitable size to manufacture the required specimens was taken. Ordinary Portland Cement was added on a dry mass to dry mass basis to give the required percentage addition rate and then mixed thoroughly using a multi flow mixer. Specimens were compacted immediately after cement addition using the compactive effort shown in table 1. The compacted specimens were trimmed to a suitable size for permeability testing(100mm length).Prepared specimens were sealed in polythene and stored until the required test date at 18-22°C. Duplicate specimens were prepared for each cement addition and compactive effort.

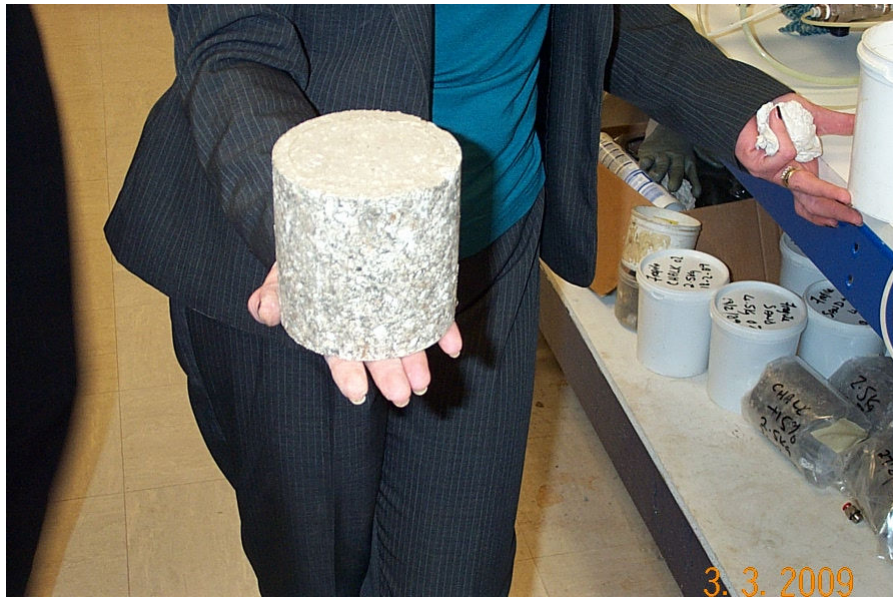
Figure 3. Compacted chalky sub-soil sample with cement inclusion

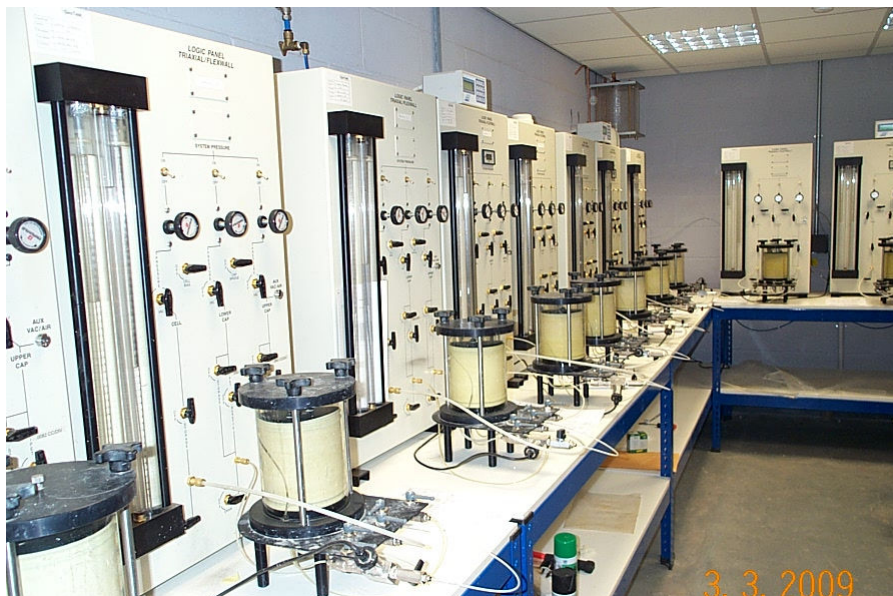
Figure 4. Sub-soil samples - Permeability testing at GeoTest laboratory

Prepared specimens were stored for approximately 23 days before commencement of testing with the aim of the permeation phase of the test taking place when specimens were 28 days old. Triaxial Permeability tests in accordance with BS 1377:1990 Soils for civil engineering projects, Part 6, method 6 were carried out using an effective pressure of 50kPa, a hydraulic gradient of 20 and downwards flow through the specimen. The permeability of each specimen was determined when flow volumes from upper and lower inlets were linear and parallel.

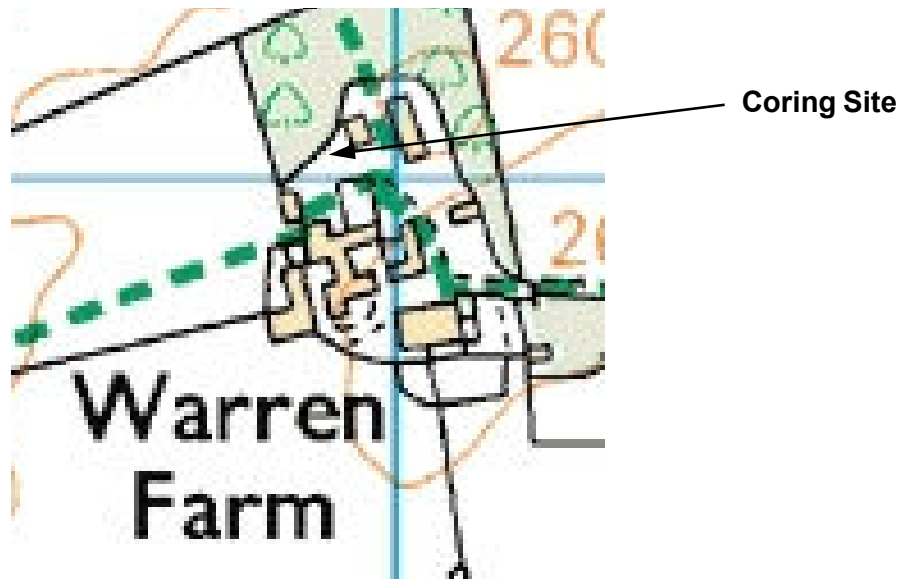
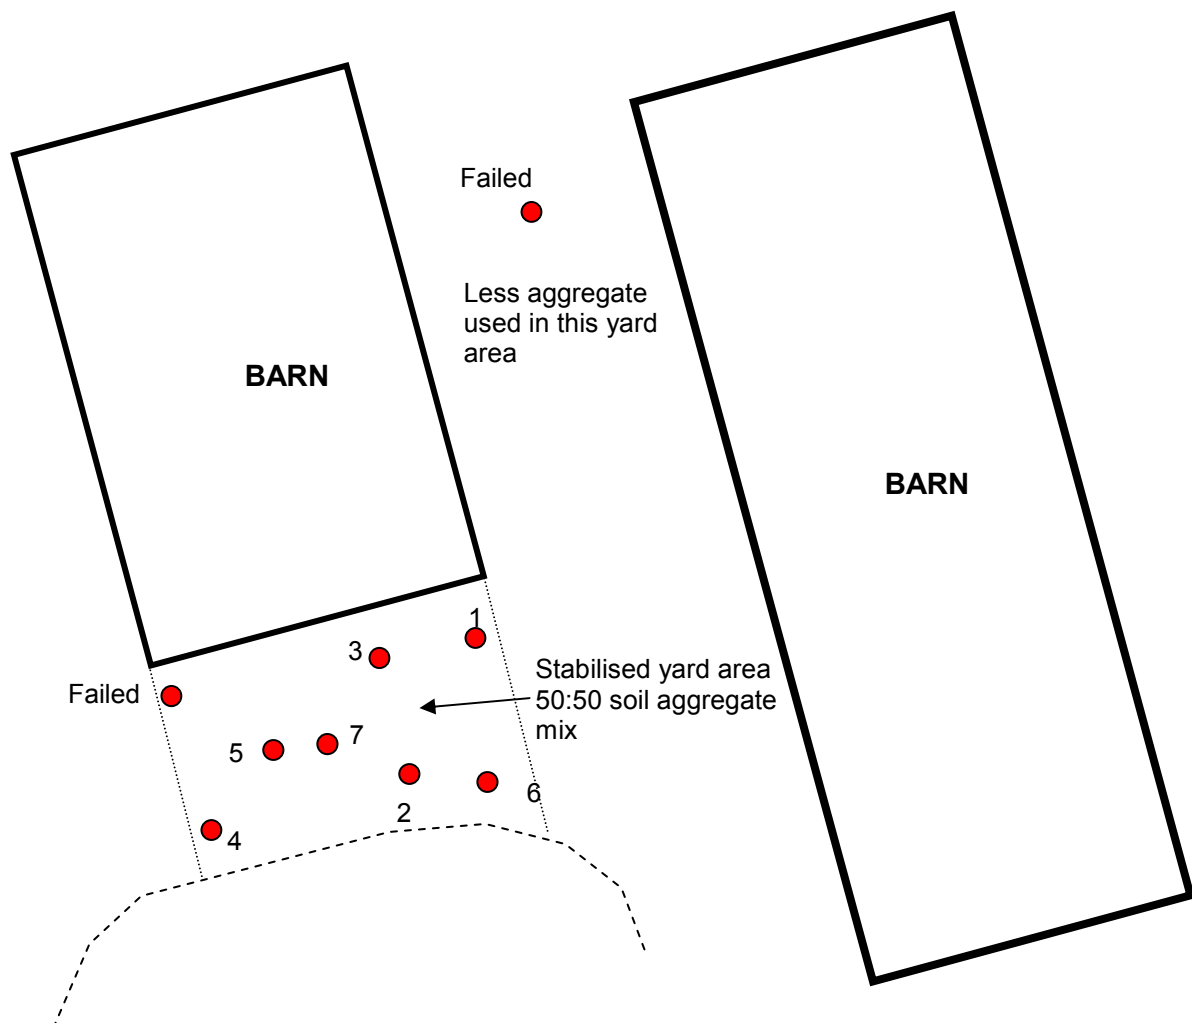
## Approximate Location of Core Samples - Warren Farm

Not to scale

Nine cores were taken within the yard area. Some of the cores disintegrated on extraction from the coring machine which left seven cores suitable for testing purposes. Two bulk samples of source material were collected from a stockpile as control samples.

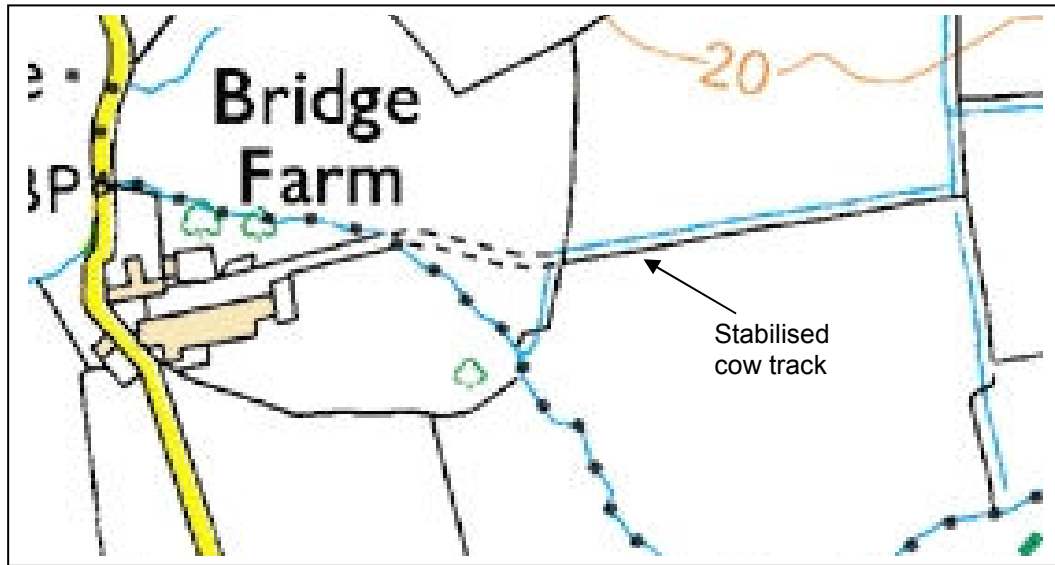
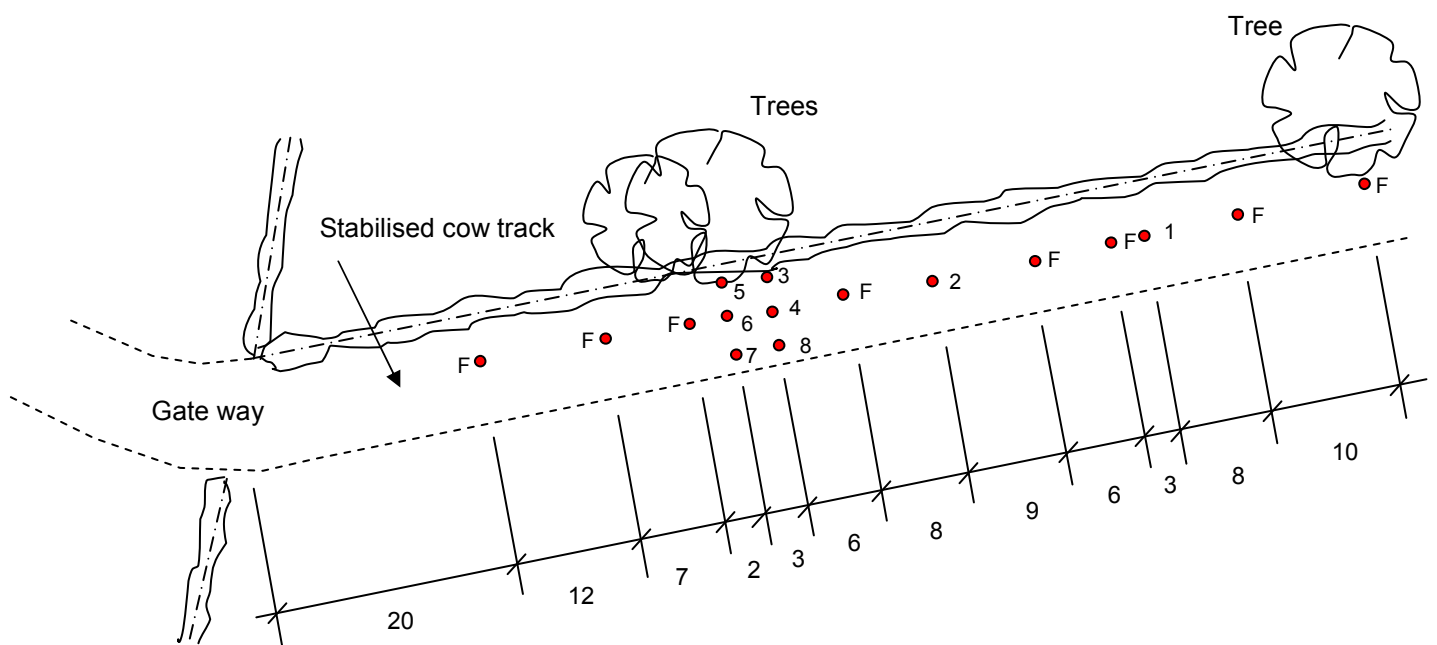
## Approximate Location of Core Samples – Bridge Farm

F = Failed core

Dimensions are in metres

Sixteen cores were taken along the cow track. Many of these cores disintegrated on removal from the coring machine. Seven cores were suitable used for testing purposes.

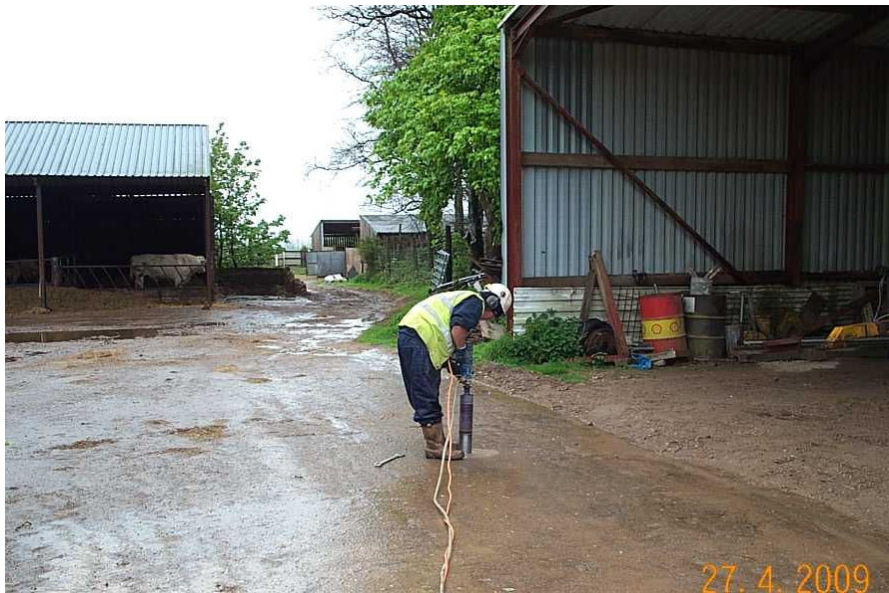
Figure 5. Coring at Warren Farm yard area

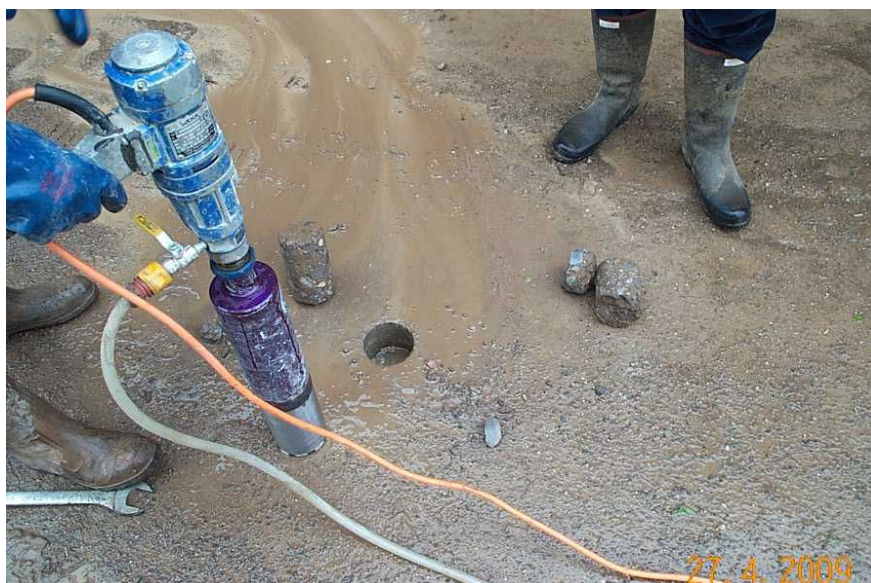
Figure 6. Coring equipment showing core removed

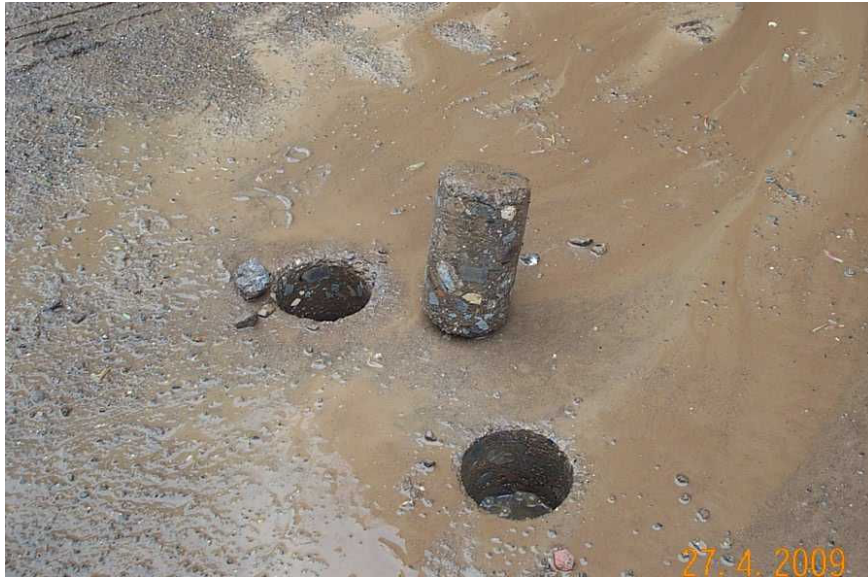
Figure 7. Core of stabilised soil material

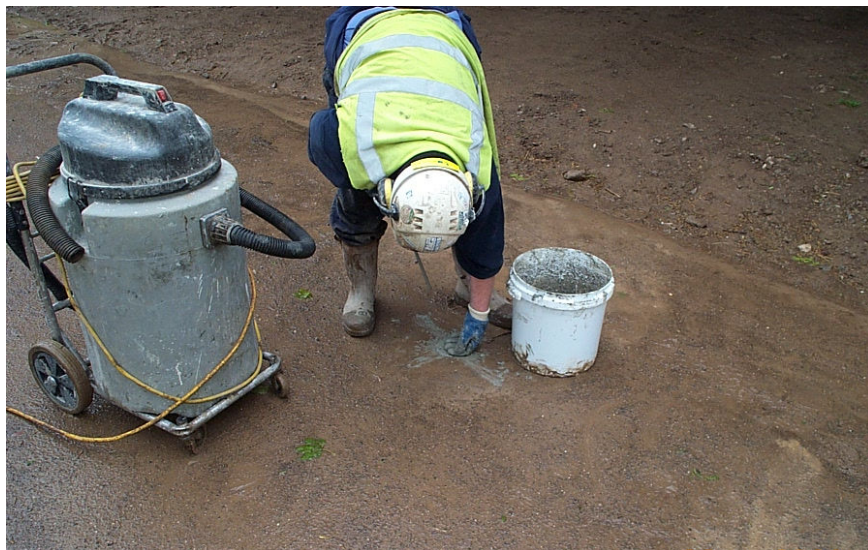
Figure 8. Vacuum used to clean out core holes prior to reinstating with concrete mix

All the cored holes were reinstated on completion with concrete.

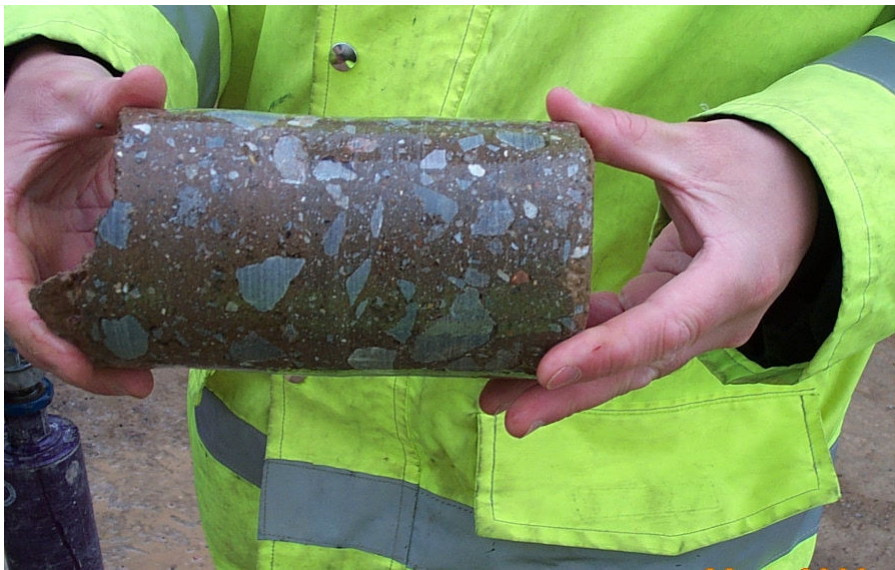
Figure 10. Example of core containing a higher percentage of aggregate

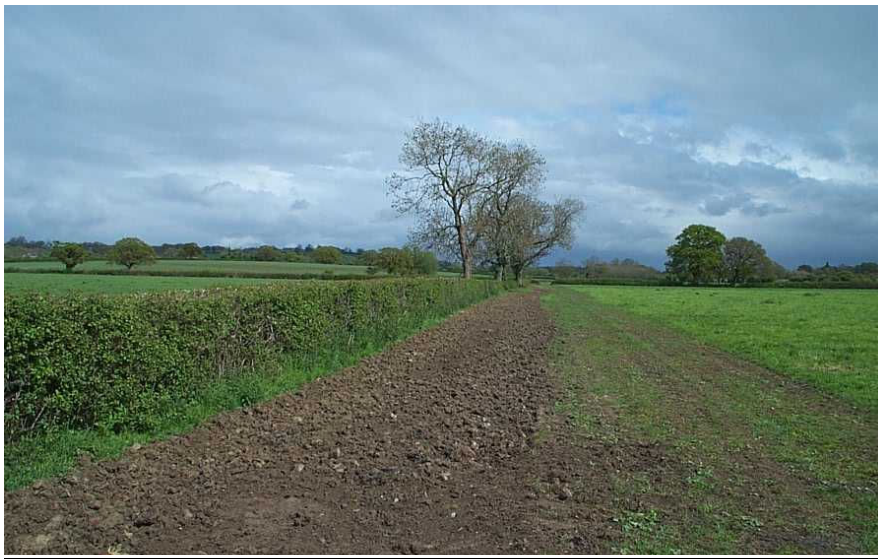
Figure 11. Bridge Farm - view along stabilised cow track before coring

The above site is a cow track which was stabilised in 2005. The stabilised track comprised a mixture of sub and top soil. The top 3-4 inches of soil was removed prior to the remainder being stabilised using MP and KM Golding's technique.

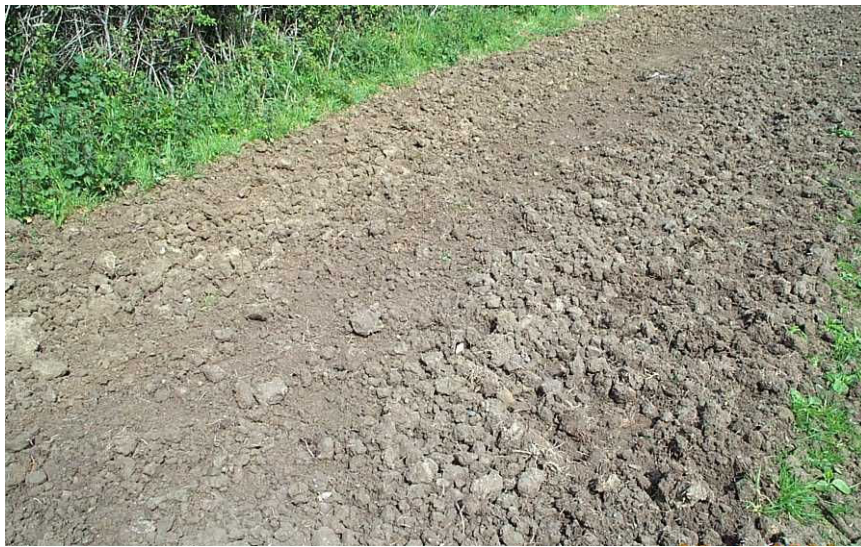
Figure 12. Close-up of surface of stabilised cow track

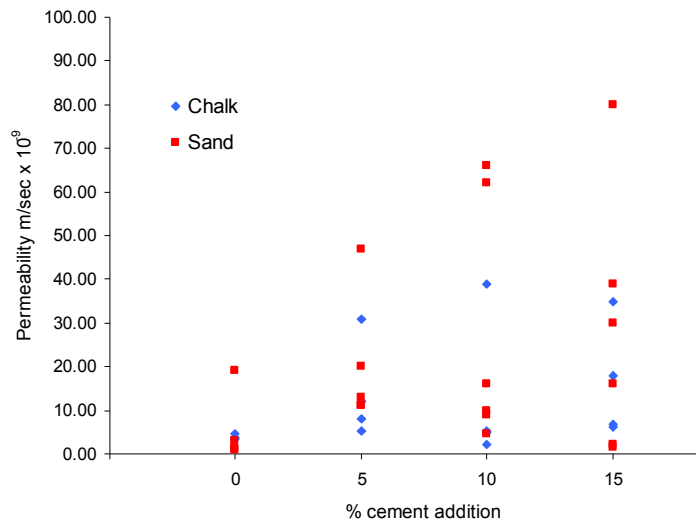
Figure 15. Soil permeability test results and rate of cement addition

A summary of the key results from the soil mix permeability tests, including also the latter, wet mix tests, is presented in Table 2. Full details of the wet mix test results are presented in Appendix 3. Overall, permeability test results were disappointing, with only four sample mixes (out of a total of 38 mixes) attaining near to, or below, the minimum standard required ( $<1 \times 10^{-9}$  m/second) for suitability for use in lagoon construction (Anon, 1991). These four sample mixes (highlighted in blue text) were all of the sandy soil, but only one of these included any cement addition (15% cement, light compaction). Neither did there appear to be any systematic difference between the results obtained for the sandy and chalk soil types. Moreover, with the results for the two soils plotted according to rate of cement addition (Figure 15), there appeared to be no discernible benefit of cement addition to resulting permeability; rather the contrary, with cement addition to the soil mix tending to increase the permeability of the final mix.
